# **Hydroacoustic Mapping to Define Sedimentation Rates and Characterize Lentic Habitats in DeSoto Lake, DeSoto National Wildlife Refuge**

By Caroline M. Elliott, Robert B. Jacobson, and Kimberly A. Chojnacki

Open-File Report 2006–1254

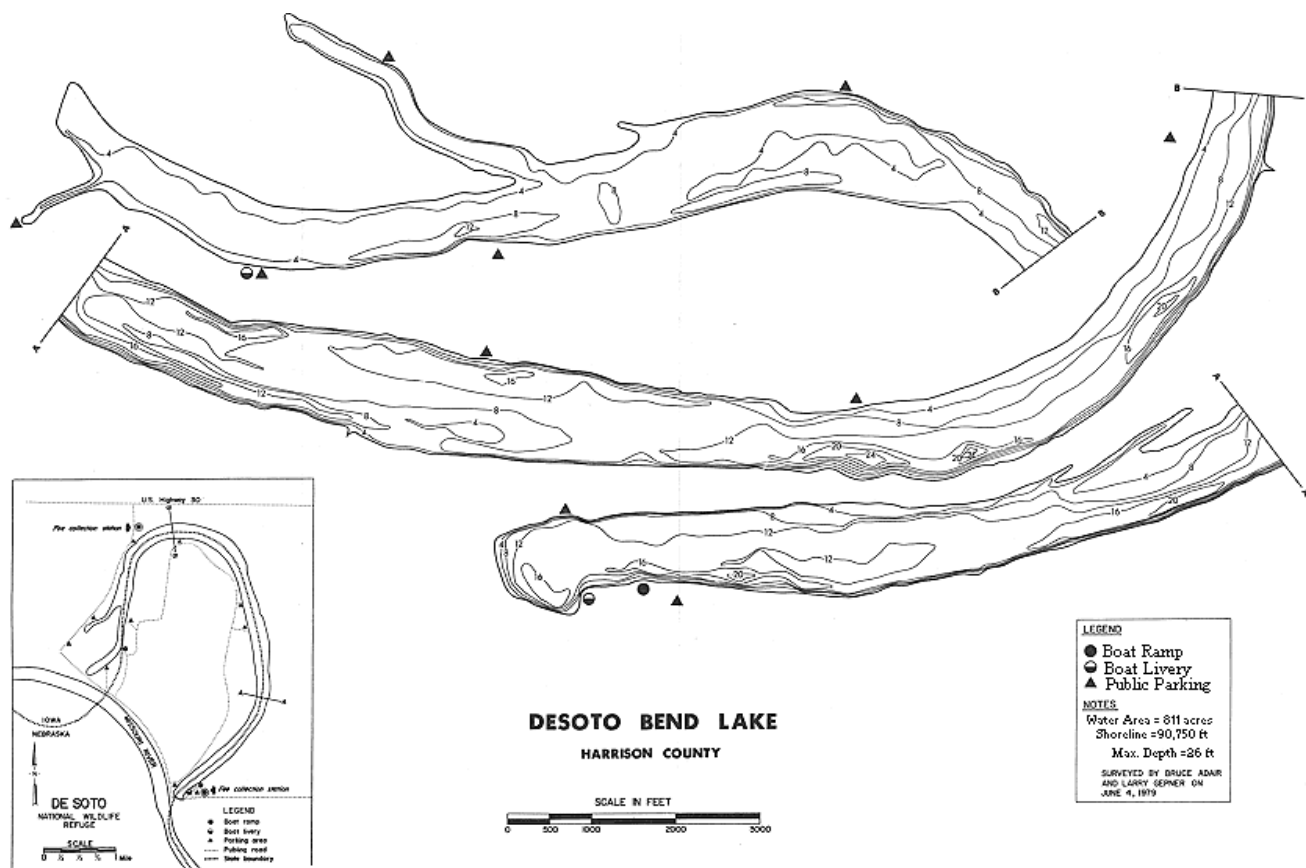
Figure 3. DeSoto Lake in 1979 (Iowa Conservation Commission, 1980).

Refuge records indicate that the lake was mapped in March 1967 by the U.S. Fish and Wildlife Service. The archived maps are 5-foot interval contour maps of depth mapped from a lake elevation of 988.5 ft (feet). The lake was surveyed again in June 1979 (fig. 3). The lake elevation at the time of this mapping was not documented, and the contour interval is 4 ft. Both the 1967 and 1979 maps were hand-contoured from surveys with undocumented data density. This makes quantitative comparison to the 2006 mapping impossible, as actual elevations of the bottom cannot be determined. As part of a lake assessment of all large Iowa lakes in 2004, the Iowa State University Limnology Lab created a grid from the 1979 mapping and compiled physical characteristics of DeSoto Lake in a report (Bachmann, 1994). The grid is interpolated from contour data, does not indicate water surface elevations, and cannot be used to calculate sedimentation rates.

The 1979 bathymetric map was only available in paper and scanned format. For a comparison analysis, the scanned 1979 map was clipped using image processing software and roughly georeferenced in ArcMap by matching to 2002 digital orthophotography acquired from the Iowa Department of Natural Resources. The resulting 4-foot contour map can be overlain and qualitatively compared to the 2006 bathymetric mapping. In general, there appears to be a shallowing trend in the overall bathymetry of DeSoto Lake in the 27-year period between 1979 and 2006, if it can be assumed that lake elevations were similar during the two surveys. Under this assumption, there appears to be detectable change in the regions where the three ditches, Young's Ditch, Rand's Ditch, and Brown's Ditch, enter the lake (fig. 12). Near Young's Ditch on the north end of the lake, the deepest part of the channel is now 8 ft, compared to 12 ft in 1979. There appears to have been sedimentation near Rand's Ditch on the west arm of the lake as the 8-foot contour line is no longer adjacent to the ditch's mouth. There also appears to be around 4 ft of sedimentation near Brown's Ditch. Sedimentation appears to be mostly localized near the ditches.

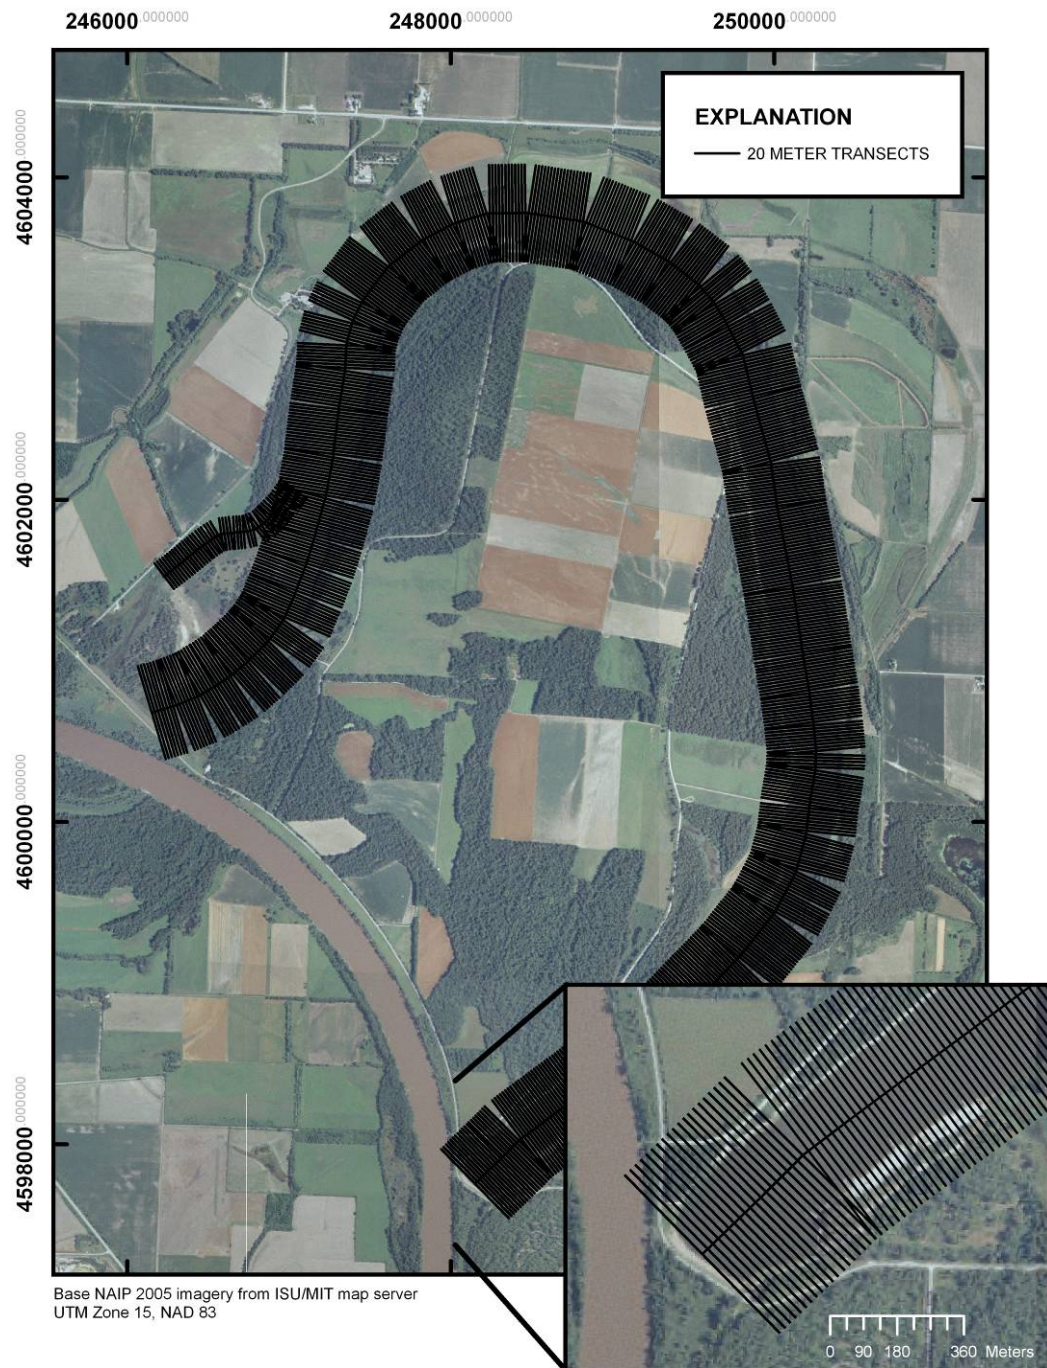
**Figure 4.** Transects created for data collection using a 20-m line spacing.

Hydroacoustic mapping was conducted using standard CERC procedures (Jacobson and others, 2002; Elliott and others, 2004). Transects were planned using digital aerial photography of DeSoto Lake acquired from the Iowa State University/Massachusetts Institute of Technology map server. The digital maps were used as base maps for transect design and real-time navigation using HyPack hydrographic software (Coastal Oceanographics, Middletown, Connecticut). Sampling transects were generated with a 20-m (meter) spacing and oriented generally perpendicular to the lake centerline (fig. 4). The transect spacing was selected to provide sufficient spatial coverage for creating continuous

surface maps of depth, elevation, and substrate data given usual scales of variation of these characteristics. DeSoto Lake's centerline is 12-km (kilometers) long; therefore, approximately 600 transect lines were drawn for data collection (fig. 4). Transects were terminated laterally when the depth became too shallow for the boat to survey at approximately 0.30 m.

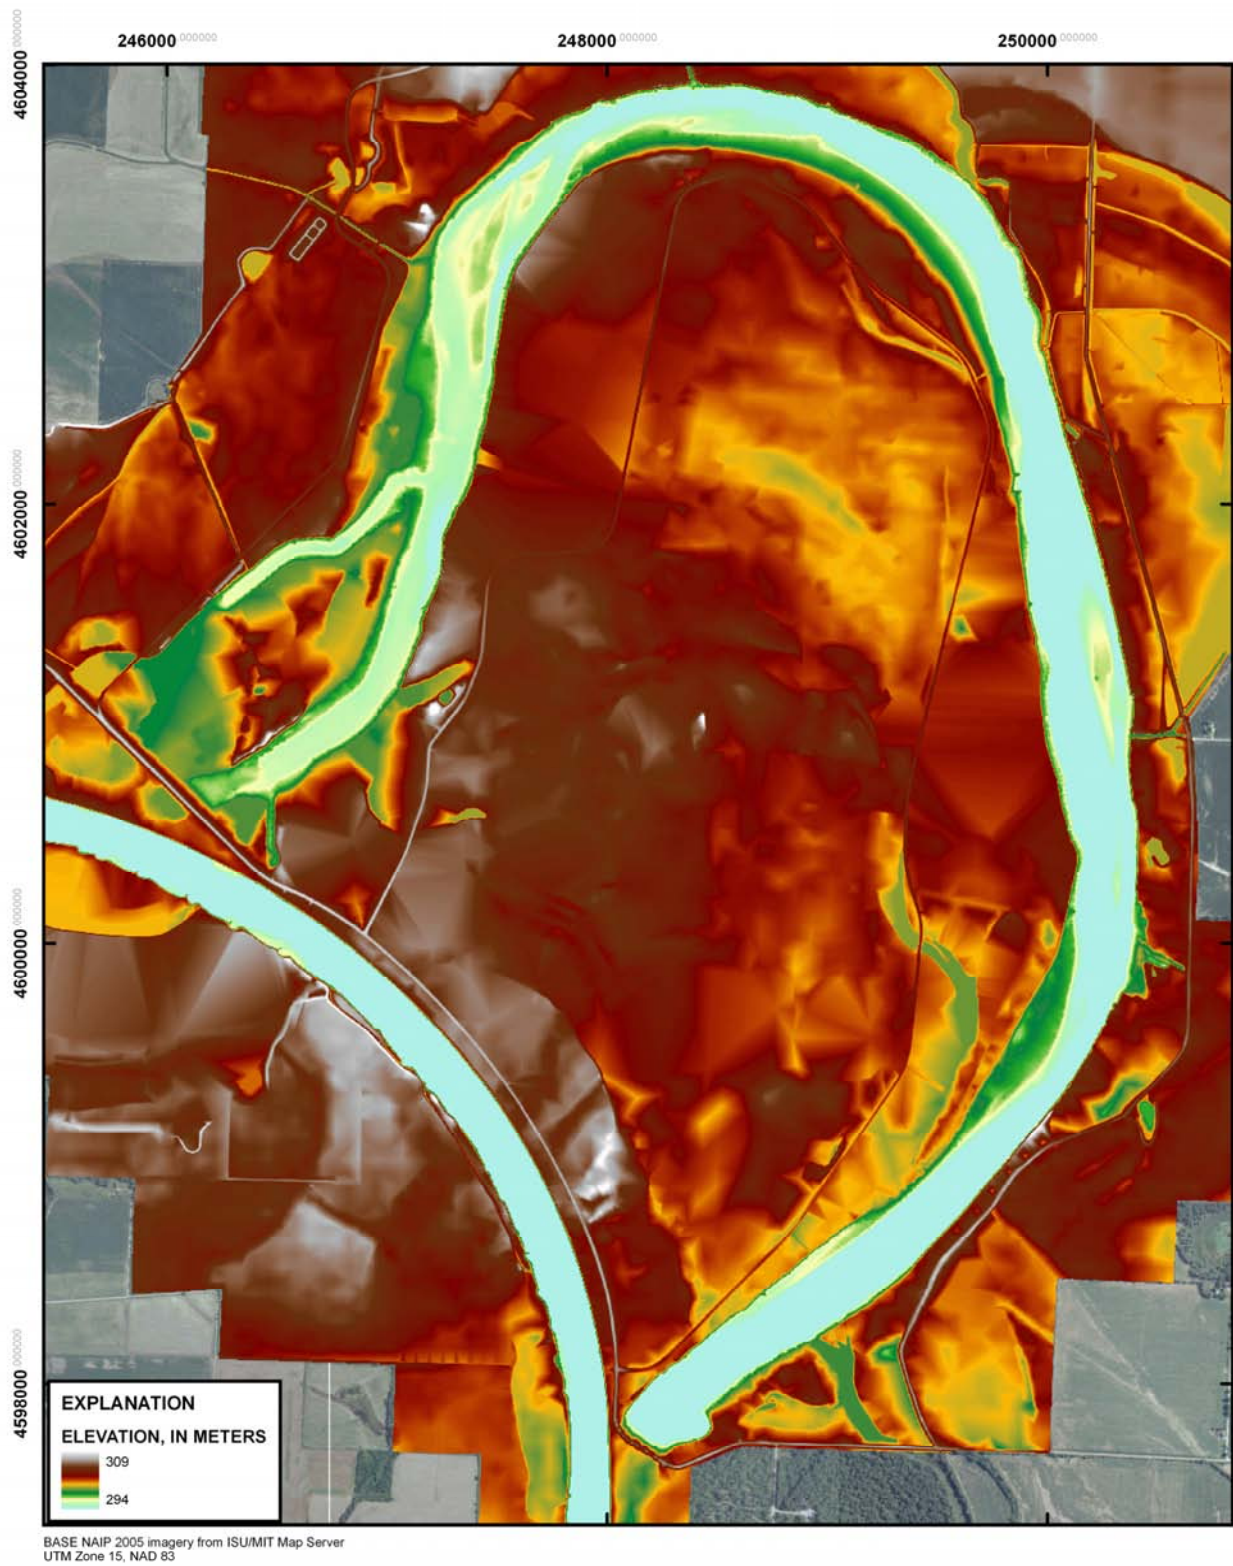
**Figure 9.** Elevation of DeSoto National Wildlife Refuge, 2006.

Maps of elevations in DeSoto Lake and the DeSoto NWR region are shown in figures 8 and 9. Individual surveyed transects tied to elevations are stored in archival formats that can be used for a precise transect-by-transect assessment of sedimentation rates during subsequent resurveys of the lake.

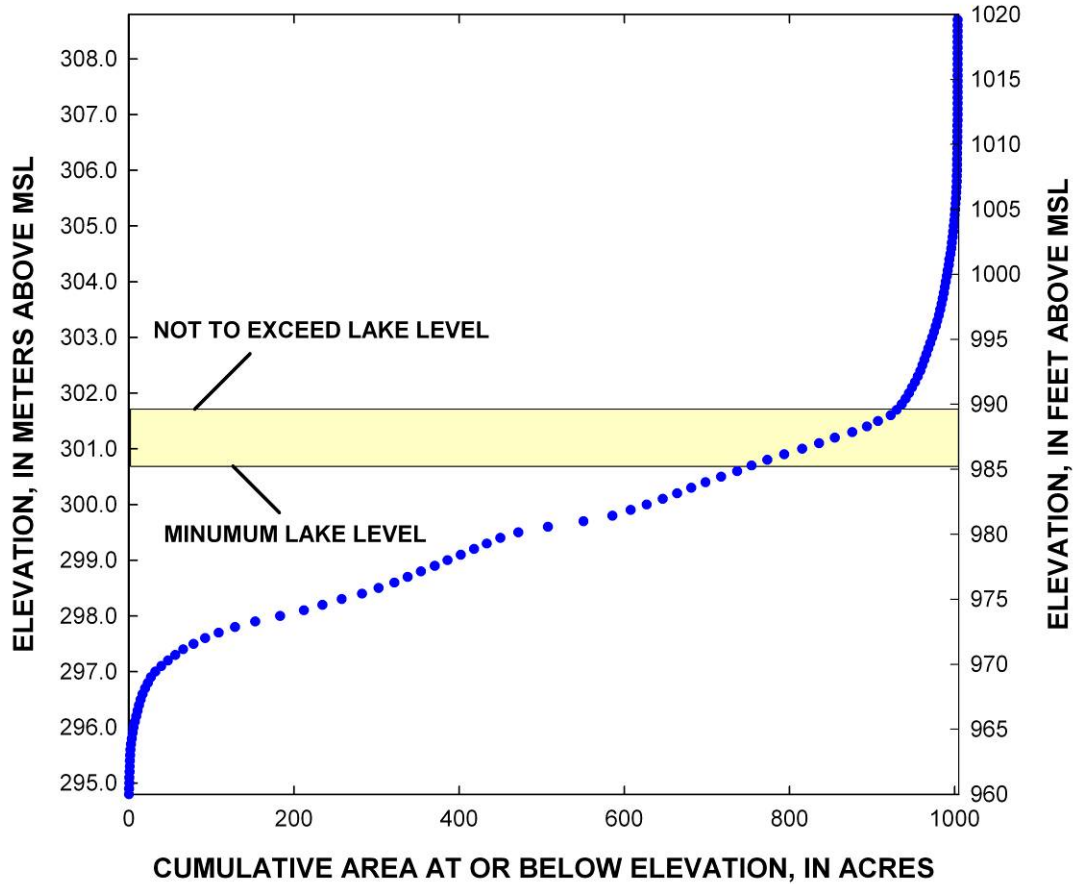
**Figure 14.** Hypsometric graph for DeSoto Lake with optimal minimum- and maximum-lake elevations indicated. Lake level information is from the DeSoto National Wildlife Refuge Comprehensive Conservation Plan (U.S. Fish and Wildlife Service, 2001).

In the 46 years since the lake was cut off from the Missouri River channel, DeSoto Lake still retains many features from the Missouri River. According to the DeSoto NWR Comprehensive Conservation Plan, the ideal lake level for DeSoto Lake fluctuates between 300.8 m MSL (986.5 ft) and 301.7 m MSL (989.5 ft) (U.S. Fish and Wildlife Service, 2001). This fluctuation affects the entire perimeter of the lake, as well as specific shallow areas on the inside of the bend and the west arm of the lake (fig. 12). Within the operating conditions between 300.8 m MSL (986.62 ft) and 301.7 m MSL (989.58 ft), there is a difference in 633,425 square meters (156.52 acres), or 16.2 percent of the total lake area below the 301.8-m contour line (fig. 13; table 4). Due to DeSoto Lake's connection with the Missouri River, the refuge has a limited ability to regulate lake level (U.S. Fish and Wildlife Service, 2001). Under ideal conditions, lake levels are drawn down in the fall for waterfowl management and predation on forage fish (U.S. Fish and Wildlife Service, 2001). In the winter, lake levels are higher to reduce fish winterkills, and lake levels are reduced in the spring to accommodate spring runoff. When river levels are above the inlet elevation, it is no longer possible to manage lake levels and unfavorably high lake conditions can occur (U.S. Fish and Wildlife Service, 2001).
